### SUMMARY 1234 Main Street Saucier MS 39574 Buyer Name 10/24/2022 9:00AM

Summary ONLY shows the prioritized observation and immediate concern items found in the home (orange/red). It's recommended the FULL REPORT be reviewed as all items noted will be listed only in the full report.

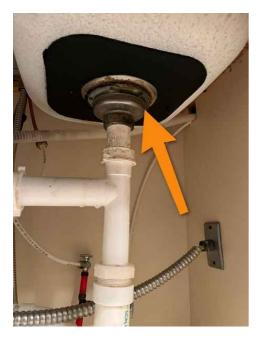
6.3.1 Sink CRACKED, LEAKED

The kitchen sink was leaking at the time of the inspection. The Inspector recommends that you consult with a qualified contractor to discuss options for repair or replacement.

Recommendation

Contact a qualified plumbing contractor.

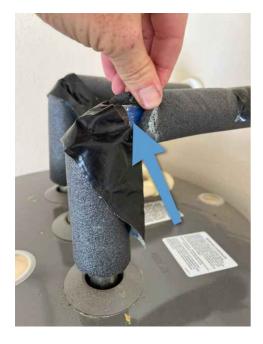
### 10.2.1 Hot Water Systems

#### **IMPROPER INSTALLATION**

Water heater had pex installed within 18 inches of the heater. Its advised the connections should be made of copper or similar material within that range. Recommend qualified plumber evaluate & repair/relocate.

Recommendation

Contact a qualified plumbing contractor.

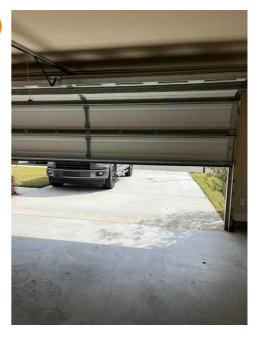
# 12.4.1 Vehicle Door OPERATION NOT OPTIMAL

Doors did open halfway only and close and did not perform as designed. Its recommended to consult with the homeowner for additional information. Its also recommended for further evaluation by a qualified professional.

Recommendation Contact a qualified professional.
